HELPING WINDSOR LEISURE CENTRE BREATHE EASY AGAIN

Leisure Centre heating, cooling and ventilation

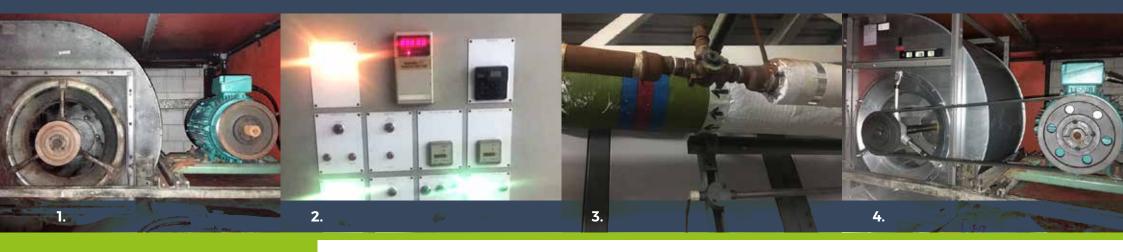
Key to photos...

The main problem was the failure of the Centrifugal Fan Assembly due to a collapsed bearing and damaged shaft. It was noted that both drive and driven pulleys were very badly worn and needed replacement, along with the appropriate belts.

Secondly the panel controlling this AHU was dilapidated and the main Satchwell controller had failed, this needed renewal along with the other repairs.

- 1. The old fan prior to removal
- 2. Dilapidated panel
- **3.** Faulty Automatic Control Valve
- 4. Repaired main AHU with new fan belt and pulleys

Thirdly to the rear of the main (failed) AHU, a smaller AHU supplying the Gym had a failed Inverter Drive and Automatic Control Valve, the Actuator having been removed some time previously. Similarly to the main AHU, both Drive and Driven V Belt pulleys were very badly worn, and the fan had become slightly noisy indicating wear to the bearings.

Eventually, as a result, the rear bearing collapsed completely and unfortunately caused catastrophic damage to the fan assembly housing, which necessitated a complete new unit.

Oakland were asked to deal with all of the problems listed above and due to the quality of the work carried out by Oakland at Windsor LC we are currently helping many other Parkwood Leisure facilities with a variety of project and maintenance tasks.
