A COMPLETE HEALTHCHECK FOR THE ROOF AT BMI HEALTHCARE, SYON CLINIC

Roof works at BMI, Brentford Syon

Eradicate leaks and water ingress into the facility

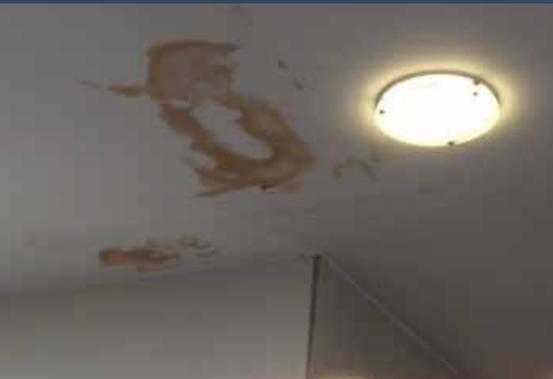
Water ingress into facility

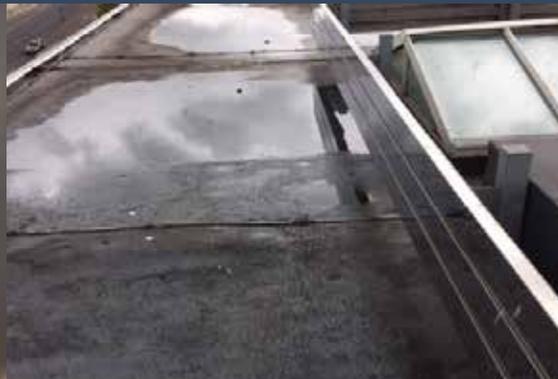
Pooling rain water on existing roof

Oakland successfully tendered a quote to repair the leaking upper and lower level roof area using 3M's® Scotchkote® 661/662 system of solvent based moisture triggered elastomeric urethane coating.

The lower roof section had decking which had to be removed section by section, then on both roofs debris was removed, the existing Terylene membrane was peeled back, the substrate cleaned, vegetation was removed, downspouts were cleared, a fungicidal wash was applied, and the surface was cleaned.

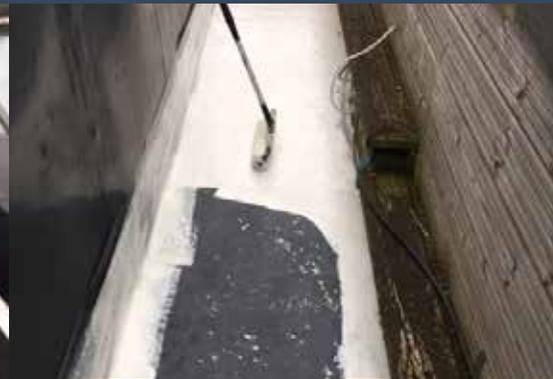
3M® Scotchkote® primer application

A primer layer was then applied, and after curing, was followed by a coat of 661 polymer, a layer of 3M® reinforcing material and finally a coat of 662 polymer.

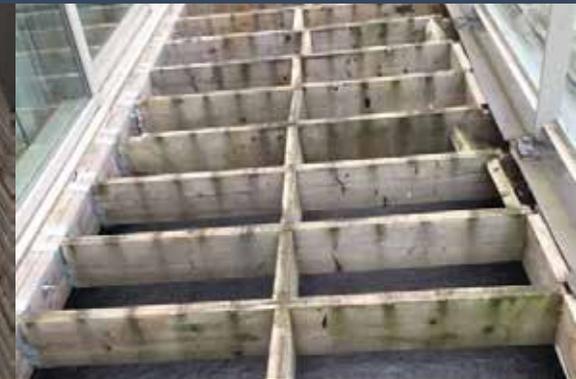
Terylene membrane with new decking

The Terylene membrane was then re-laid, the decking re-fitted (on the lower roof level) and the site cleaned.
